# Microscopic Analysis of Wrought Iron Recovered from the Wreck of RMS Titanic

*J.J. Hooper McCarty,  
T.P. Weihs  
and T. Foecke*

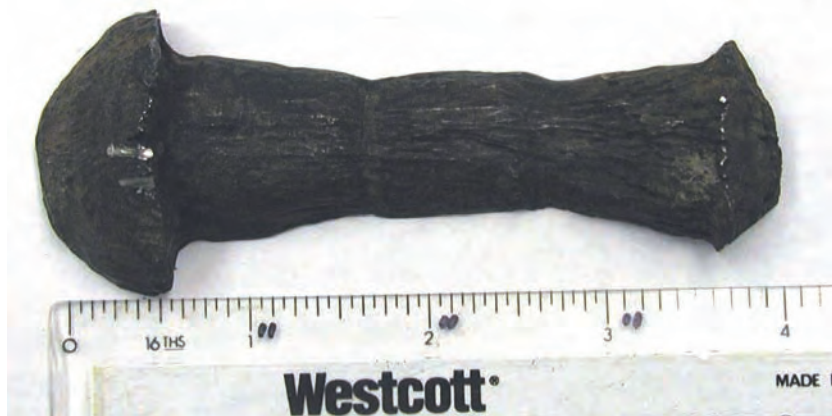
Fig. 1. A macro photo of a hull rivet recovered from the wreck site. It shows a "woody" appearance due to the ferrite being corroded away, leaving ridges of slag. The right end head of the rivet has popped off, leaving the residue of the inside of the head.

Rivets are produced from bars cut from extruded cylindrical rods (Figure 1). Sections of rods are heated in the shop and a single head is formed in a die. In a 1911 shipyard, these partial rivets were re-heated to red hot in a coal-fueled stove, and thrown to a riveting gang, who quickly inserted the rivet into the plate hole, and hammered a second head from the protruding shaft. Rivets form a watertight joint via compressive stresses that form as the rivet cools and contracts after it is hammered into place.

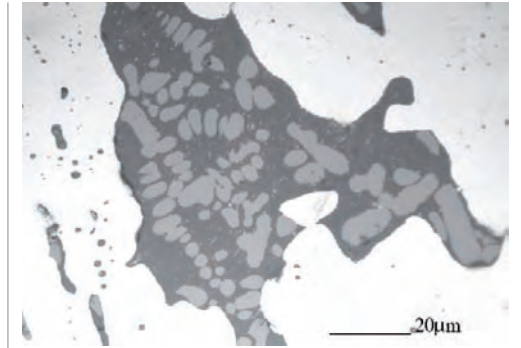
Fig. 2. A large slag particle containing dendritic crystals of iron that precipitated from the iron-silicate slag solution during cooling. Optical micrograph taken at 500X.

area percent of slag was as high as 20% in some regions, and the aspect ratio of large particles was found to be as high as 20. A number of micrographs revealed slag particles that were so large that they contained formations of dendritic crystal phases that had precipitated out of the iron-silicate solution during cooling. An example is shown in Figure 2.

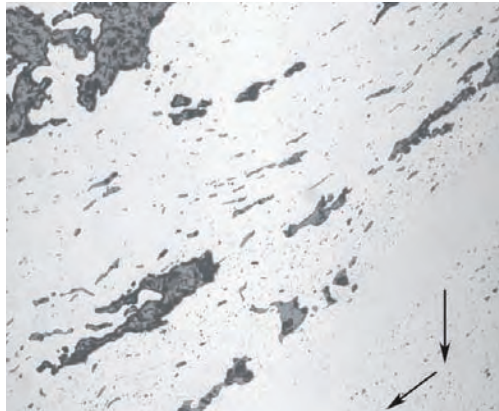
Fig. 3. Optical micrographs of Titanic wrought iron indicate considerable variability in the microstructure among rivets. In this micrograph, large slag particles are seen to follow the direction of flow during formation of the rivet head. Arrows show the gradual turn in the particle direction. Image width 2mm.

the rivet was hot. Note in Figure 3, how the slag within a Titanic rivet is oriented in a gradual 90° turn, reflecting the effects of hammering a rivet head in place. This corresponds to what we know about early 20th Century riveting procedures, where a rivet was driven and a head was hammered in place while still hot. Figure 4 shows results of image analysis from thousands of images in the cross-sectional mosaics of two Titanic hull rivets, indicating reorientation of slag stringers in the heads, which was noted in all the rivets that were studied, independent of their location on the ship.

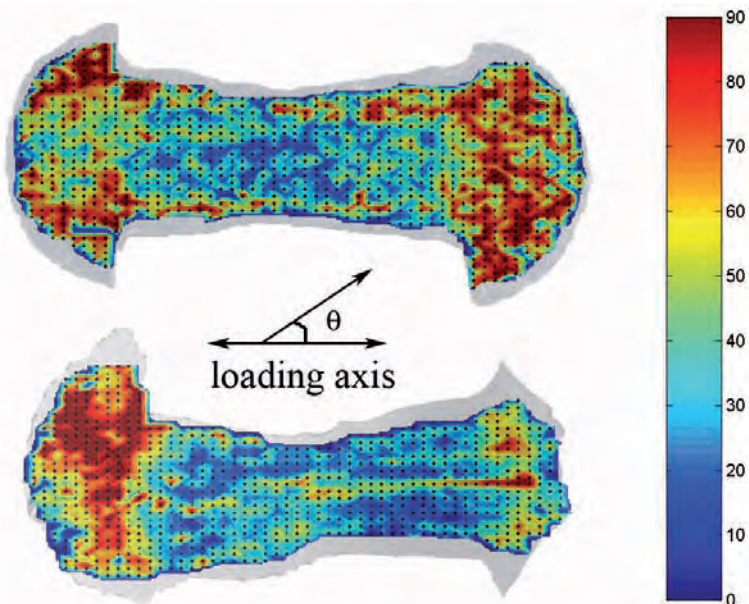
Fig. 4. Image analysis of thousands of micrographs from various regions within the cross-section of two Titanic hull rivets shows the orientation of slag particles with respect to the rivet shaft. Note the high concentration of particles in the heads of the rivets oriented at 90° (red) to the loading axis.

Image analysis revealed that in the heads of the rivets, which were hammered in place, slag is oriented perpendicular to the rivet shaft, or tensile axis. The slag particles run parallel to the rivet shaft due to extrusion while hot, which correlates with high tensile strength and ductility along the rivet shaft. Microscopy also revealed unbroken slag stringers in the rivet heads running perpendicular to the shaft, confirming that the heads were also formed while

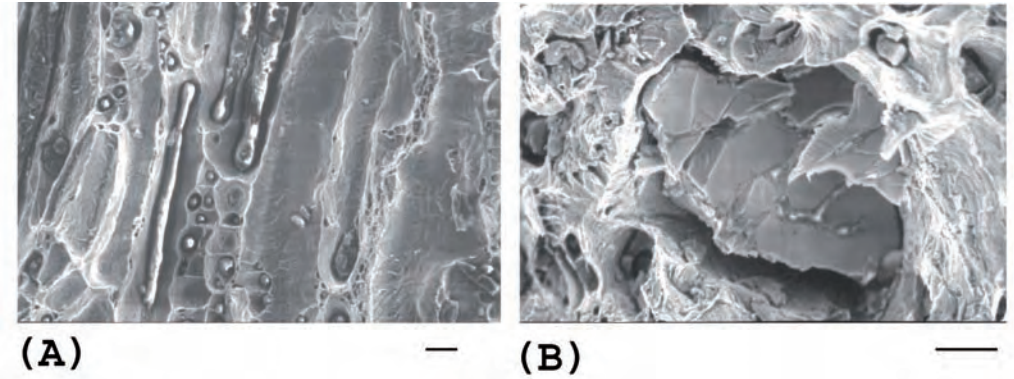
Fig. 6. Optical micrographs showing the fractured surfaces of wrought iron tensile bars. (A) Microvoids formed around elongated slag particles suggest failure at iron-slag interface. (B) Cracking in a large slag particle confirms its brittle nature. Bars represent 10µm.

The morphology of fractured surfaces further supports the hypothesis that the slag particles act as sites for stress concentrations under loading. Surfaces were analyzed post-tensile testing using a scanning electron microscope (Jeol JXA-840 Scanning Electron Microscope, Jeol USA, Inc., Peabody, MA) in secondary electron mode at 20kV. SEM images show evidence for the separation at the interface between slag and iron - the larger the particle, the larger the interfacial area. In Figure 6A, long voids surrounding slag stringers indicate that loading across the stringers has caused the iron to “peel way” from the slag. Figure 6B shows a fractured surface containing a large slag particle, clearly indicating brittle-type fracture.

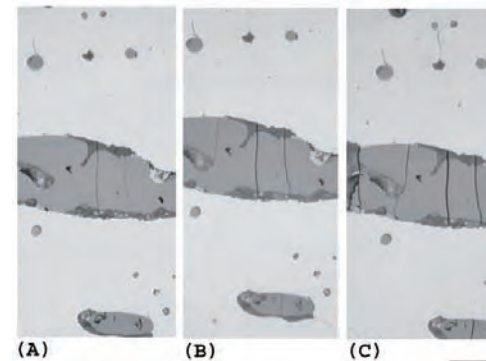
(a) With little ductility introduced into the samples, fine cracks formed across large, elongated slag particles. (b) As the strain increased, the initial cracks penetrated across slag particles. Fine secondary cracks were initiated, further subdividing large slag particles into smaller segments. (c) Small, nearly

Fig. 5. Optical micrographs showing the deformation of a slag particle in wrought iron when loaded along extrusion direction. (a) At a total strain of 1.5% (b) 2.4% and (c) 3.8%. Bar represents 20µm.

undetectable cracks were observed emanating from the slag into the iron matrix, eventually propagating and deforming along grain boundaries. Noticeably, surface roughness increased due to grain rotation. Localized regions of plasticity were seen around crack tips that have originated from within particles and have propagated into the matrix. Evidence of interfacial debonding was seen, in some cases the result of early cracking. In the later stages of yielding, slip bands are noted throughout the matrix, originating at both large and small particles.
